Manhole Inspection Summary

Manhole # S33II_016MH

Insp Date: **3/30/07 11:59 AM**

Location Address: **1711 LOVERGROVE ST**

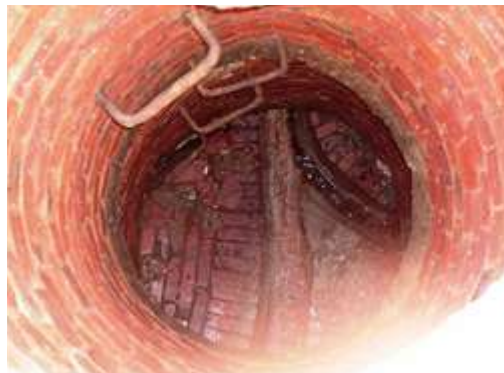
Top View

Corroded steps. Barrel infiltration.
Evidence of surcharge - Bench debris.

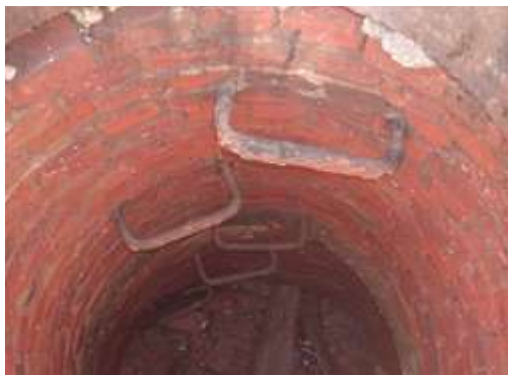
Defect

Adjustment deterioration and infiltration.
Barrel infiltration.

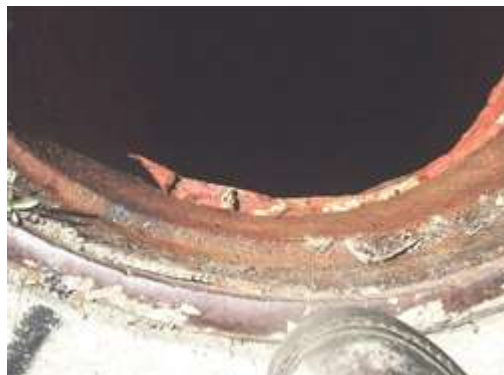
Defect

Frame offset.

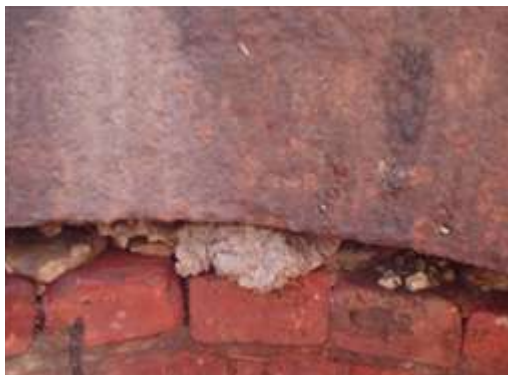
Defect

Adjustment deterioration and infiltration.

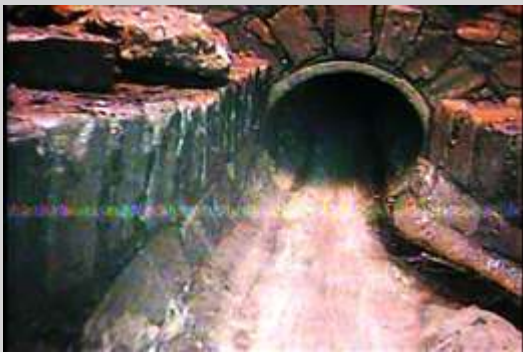
8 in. Circular Gravity Sewer Pipe Out @ 12 O'Clock

Barrel deterioration and infiltration. Channel deterioration and root intrusion.

Infiltration: **Evidence** Pipe Seal Cond: **Cracked**

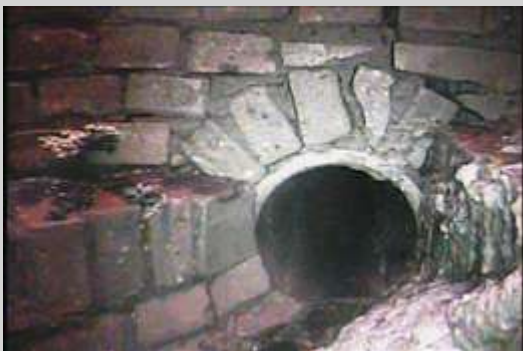
8 in. Circular Gravity Sewer Pipe In @ 3 O'Clock

Barrel deterioration, cracks and infiltration. Channel deterioration.

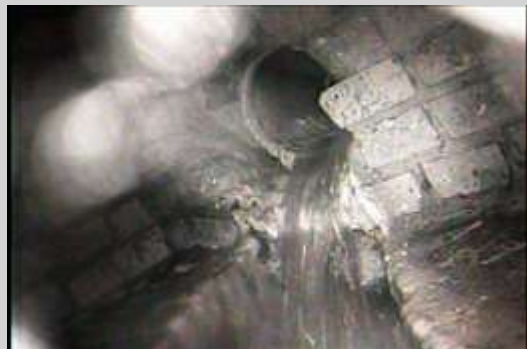
Pipe In @ 7 O'Clock

Pipe Seal Cond: **Broken**
